Caps, Croakers and Institutional Controls

An Overview of the Palos Verdes Shelf

**EPA Engineering Forum
May 8, 2001**

EPA
Region 9

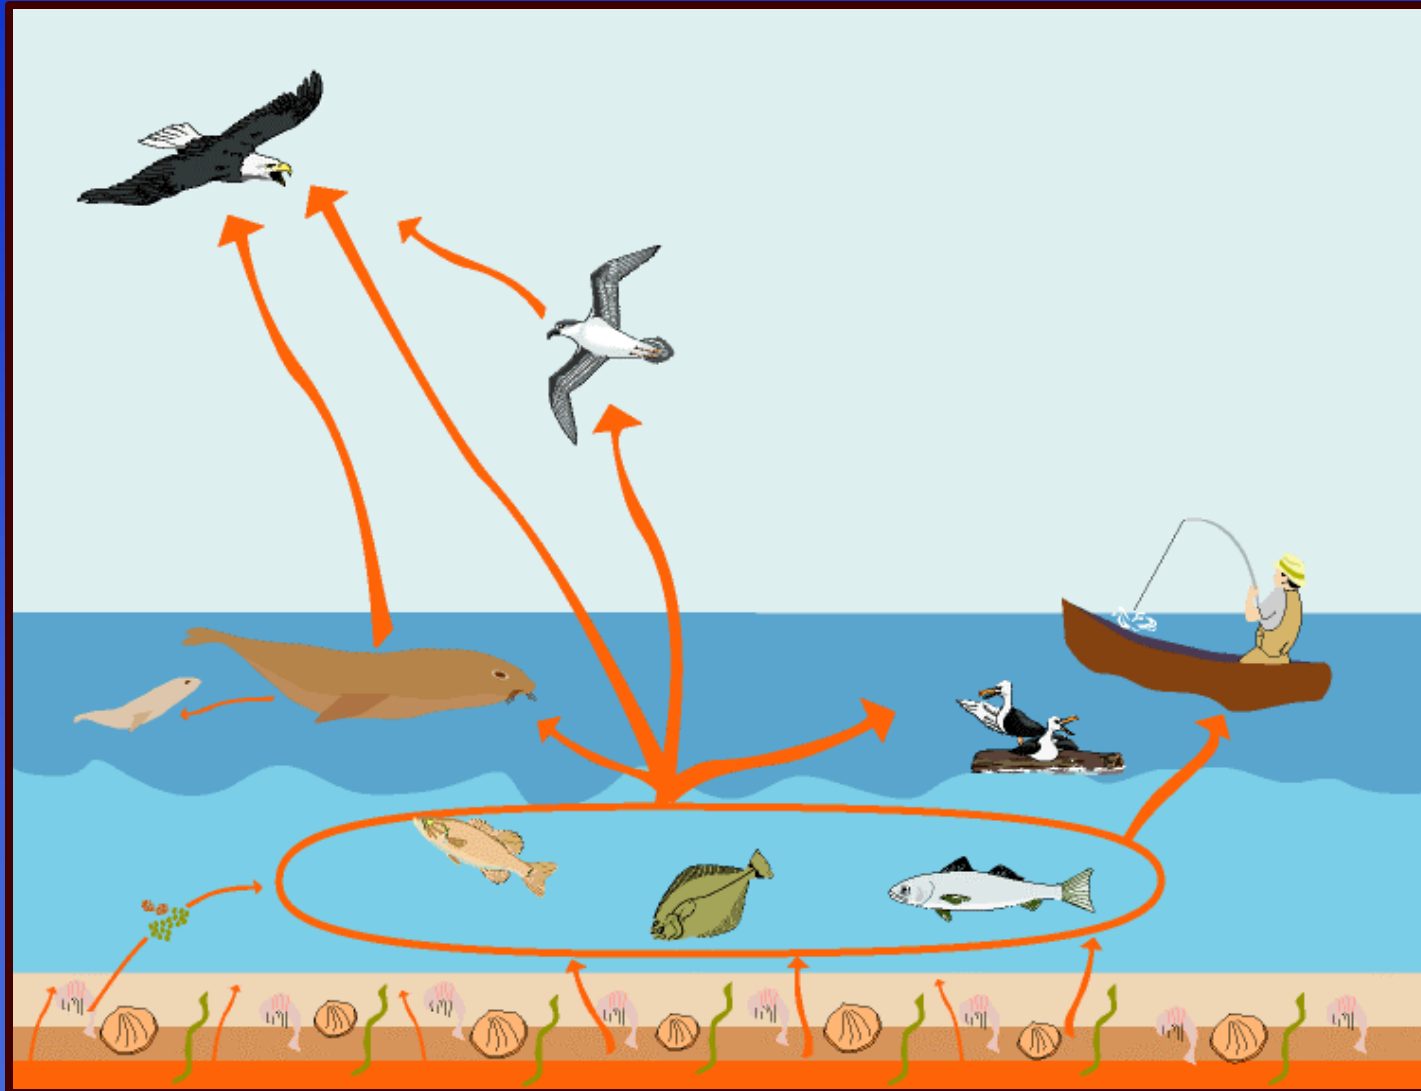
Food Web Pathways

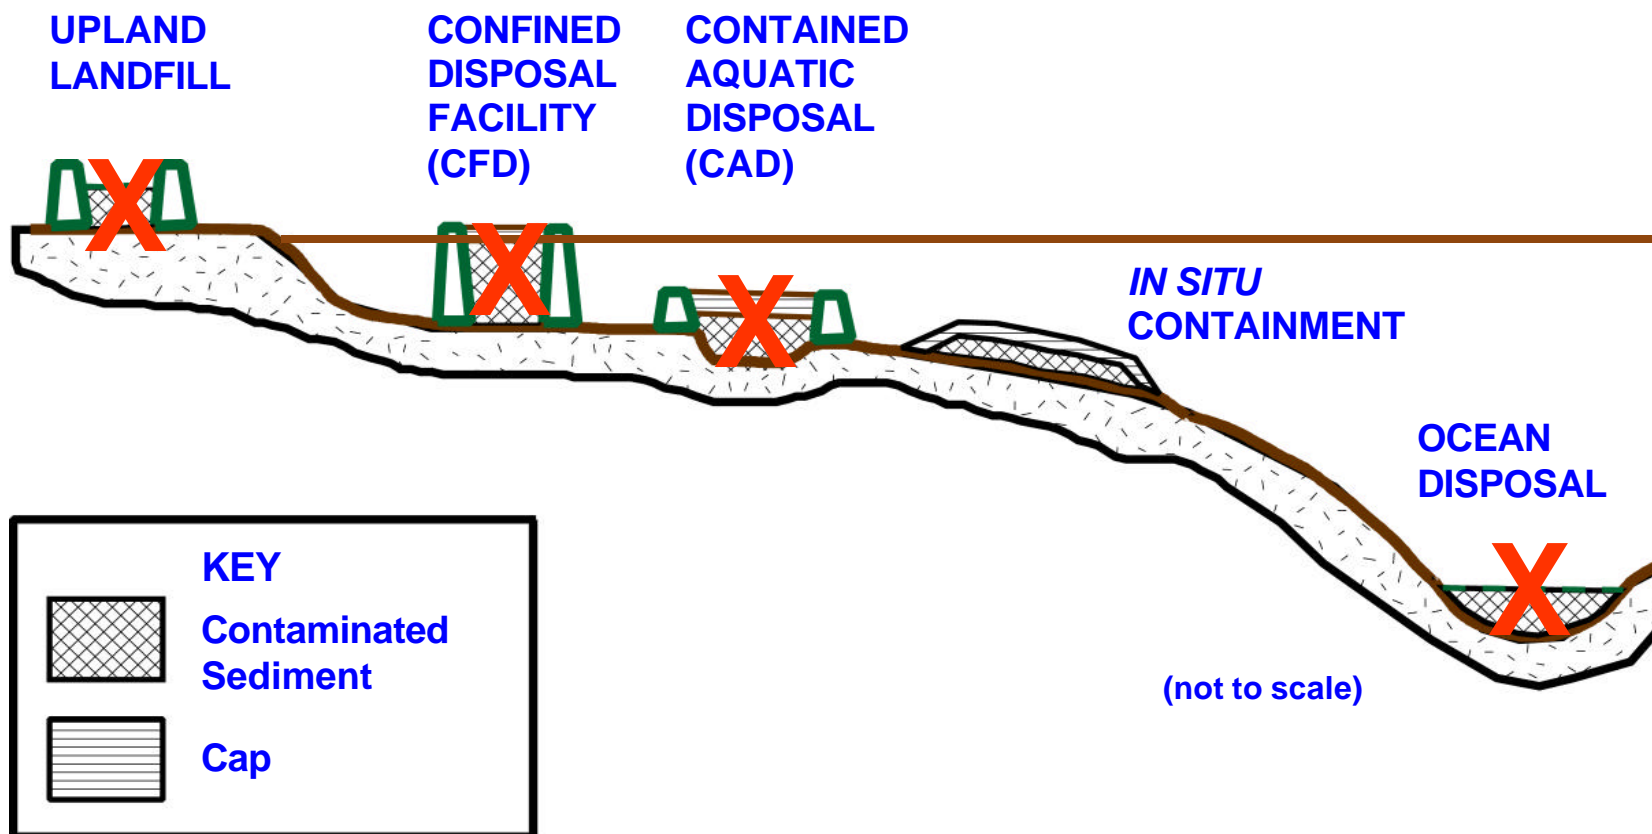
Options for Sediment Cleanup

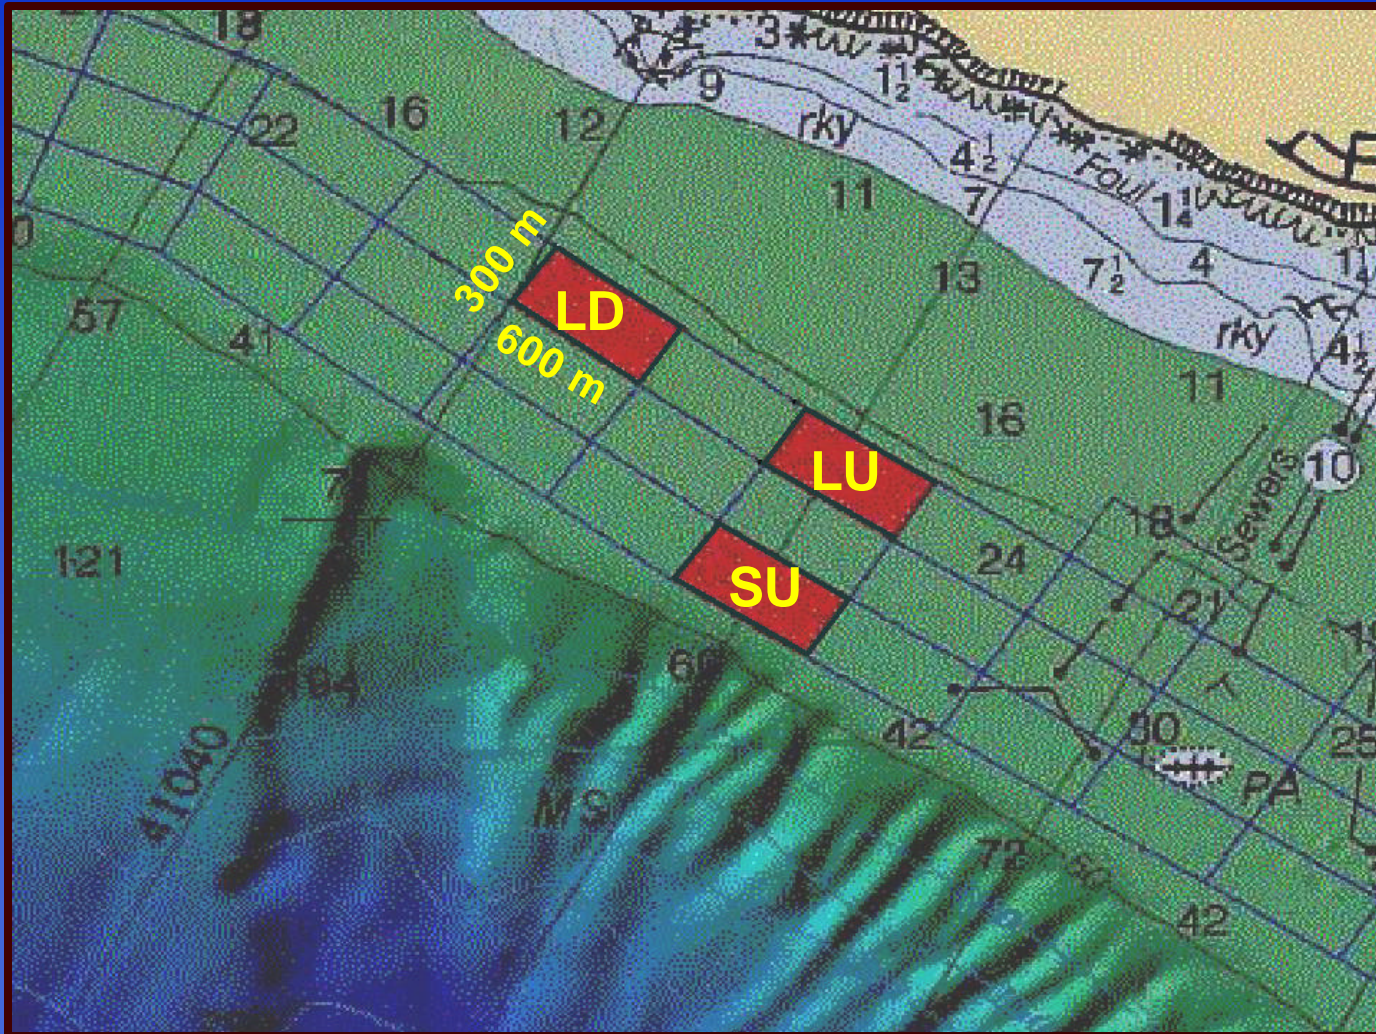
Pilot Capping Cells

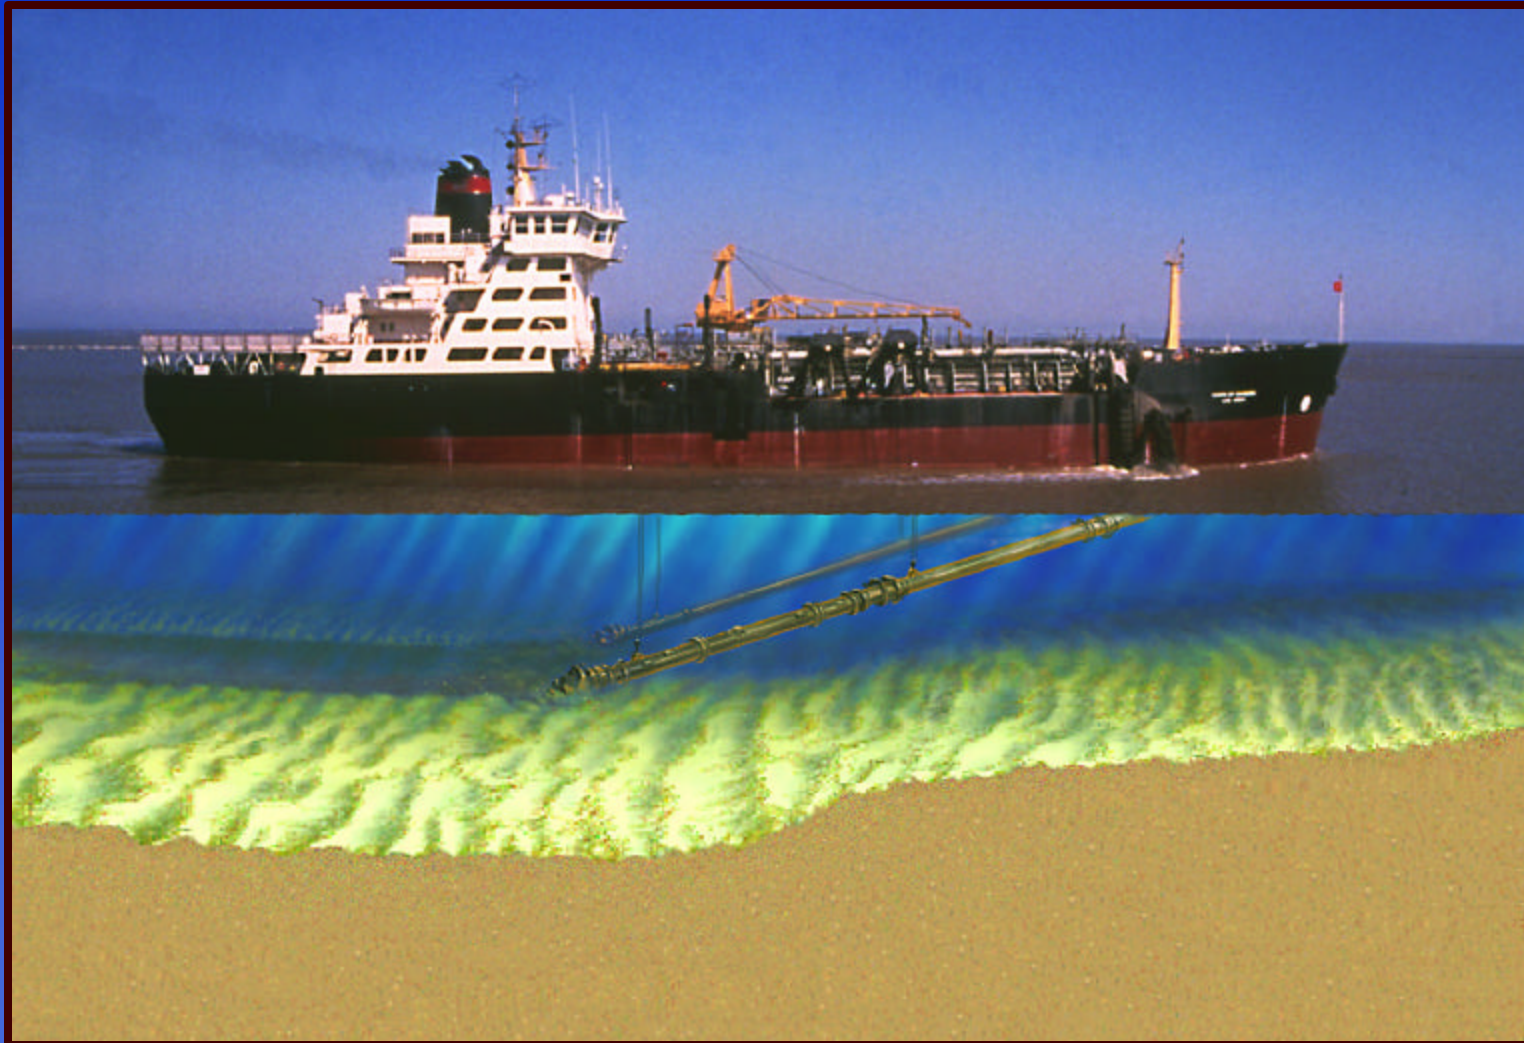
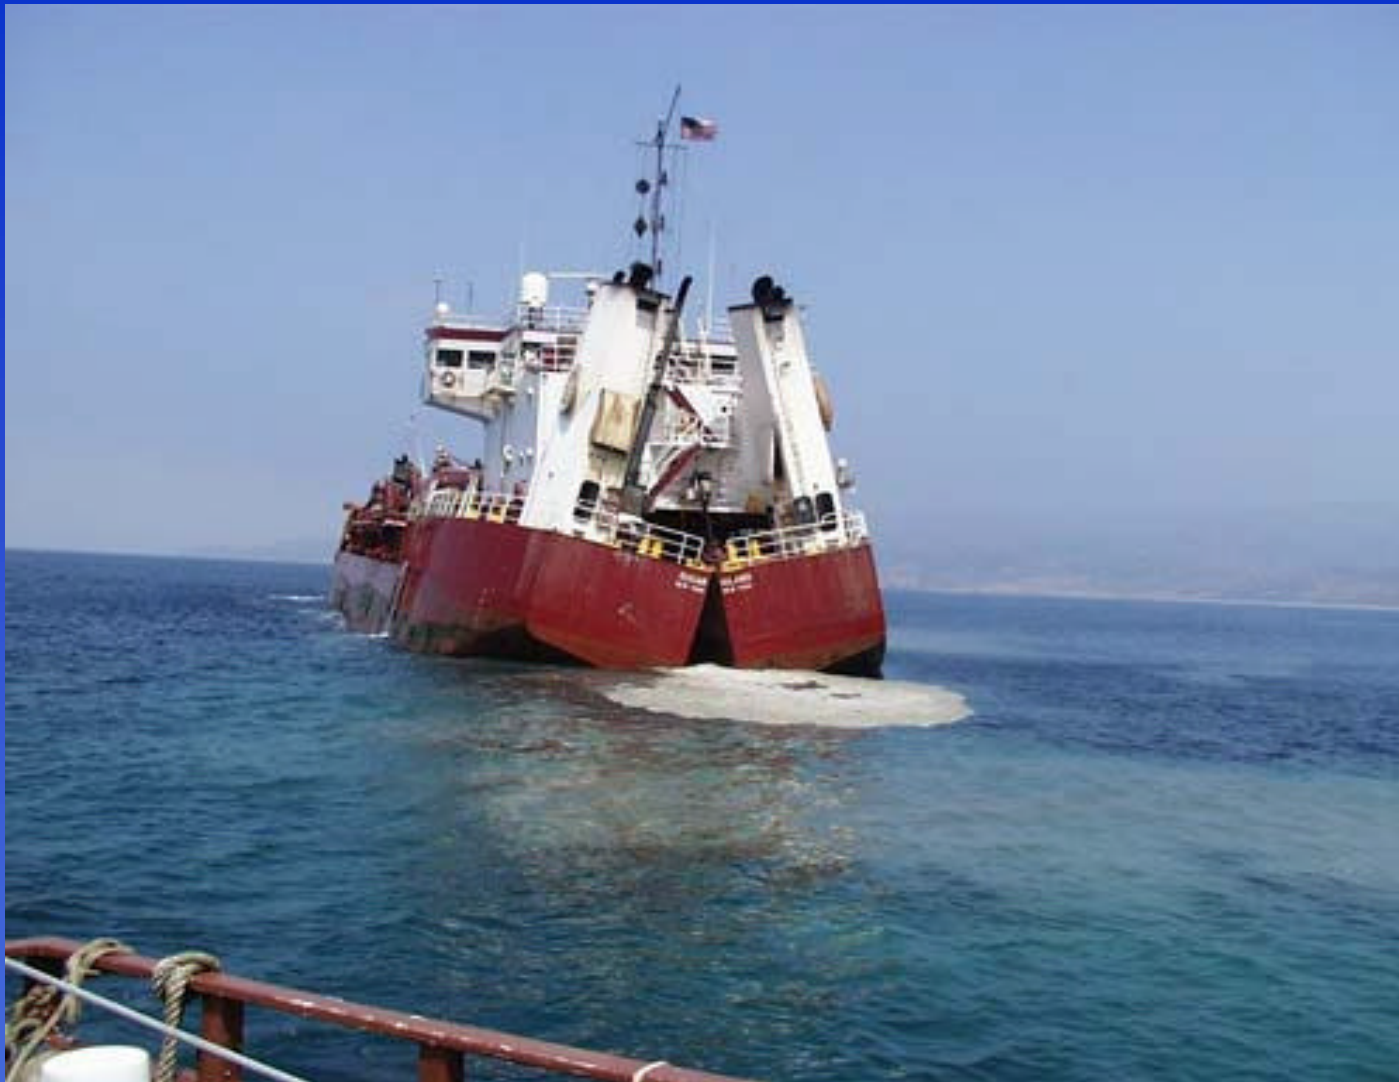
Typical Hopper Dredge

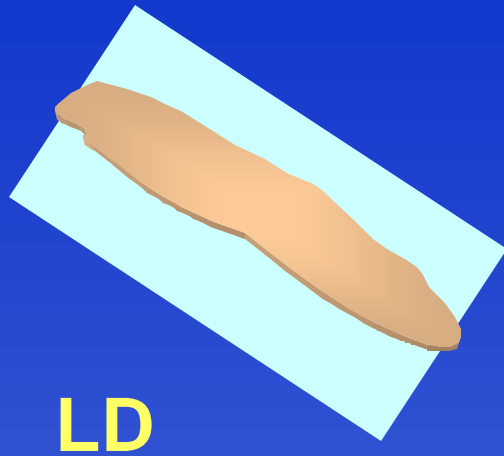
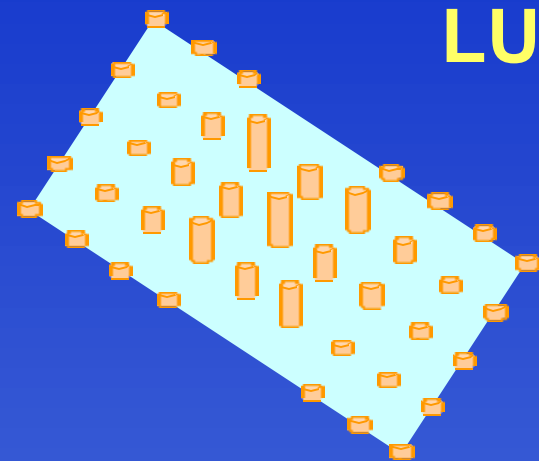
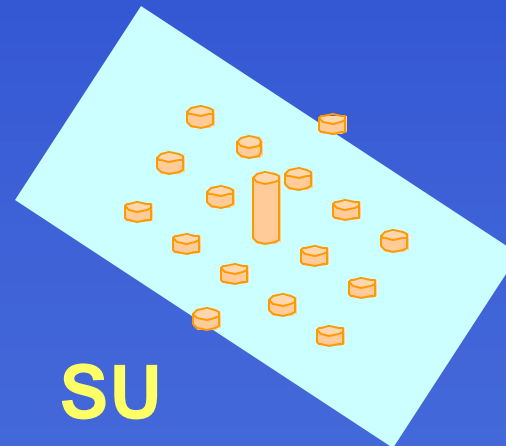
Placement Locations

= 1 load

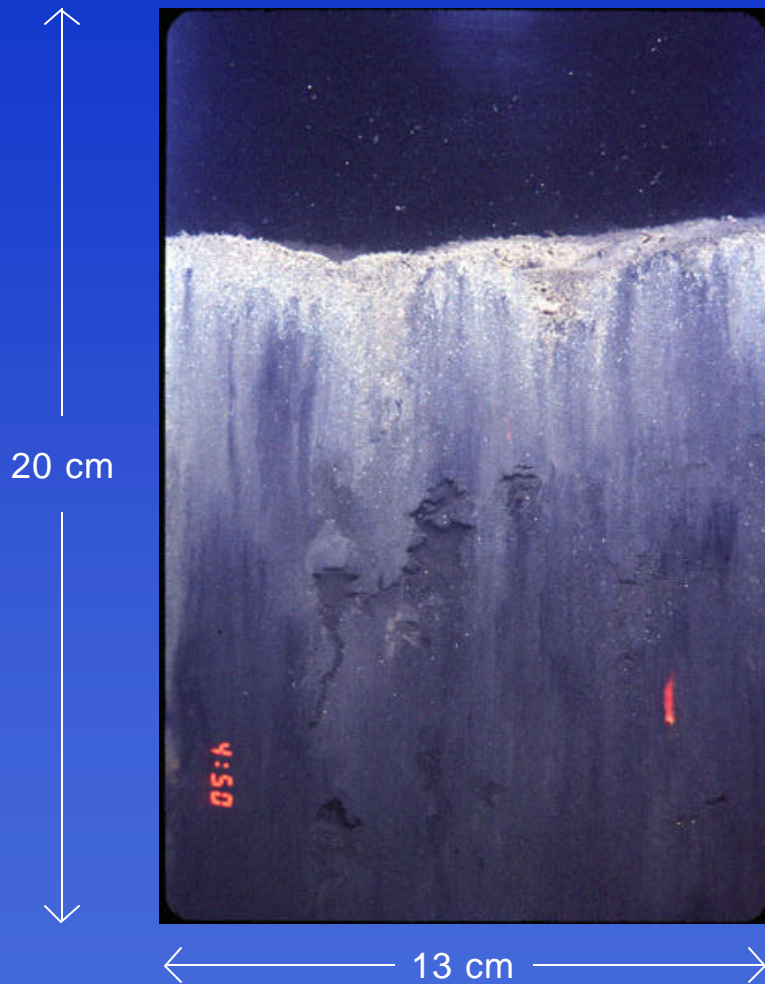
Profile

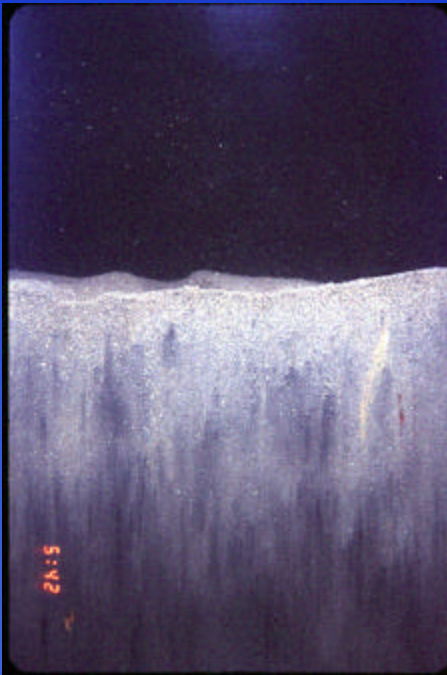
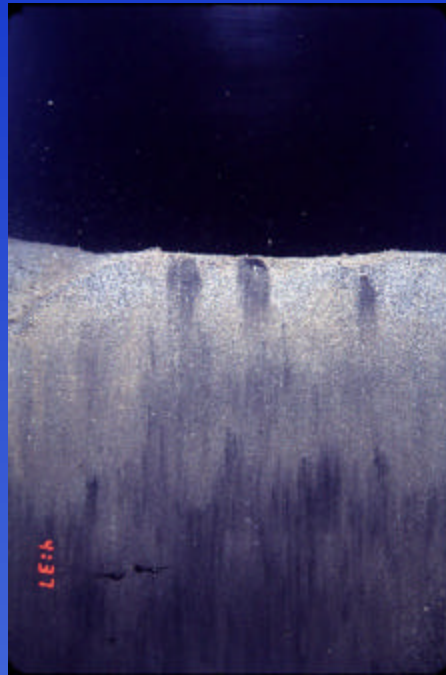
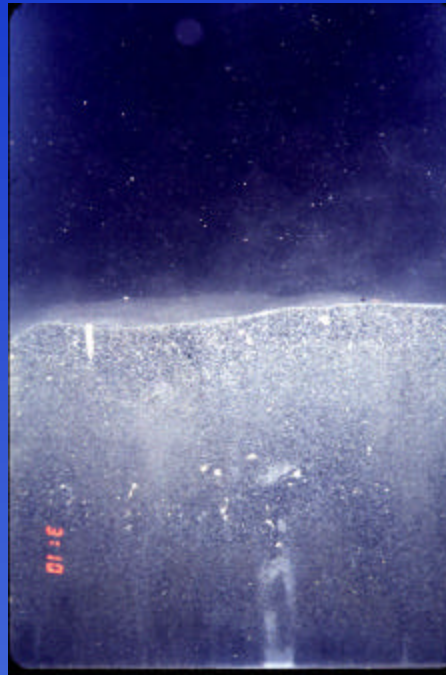
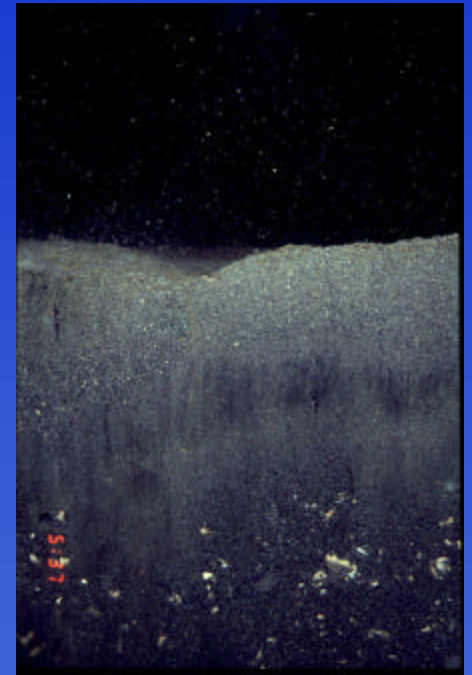
Cell LU - Station 14

Conventional Placement

Baseline

After initial dump

After 25 dumps

After 45 dumps

- ' Disturbance of contaminated sediments was relatively localized and decreased substantially after the initial load was placed.
- ' Sediment plumes caused by capping did not pose a risk to nearshore kelp beds.
- ' Spreading was less disruptive than conventional placement
- ' There were no indications of mass sediment movement (such as mud waves or turbidity flows) as a result of capping.

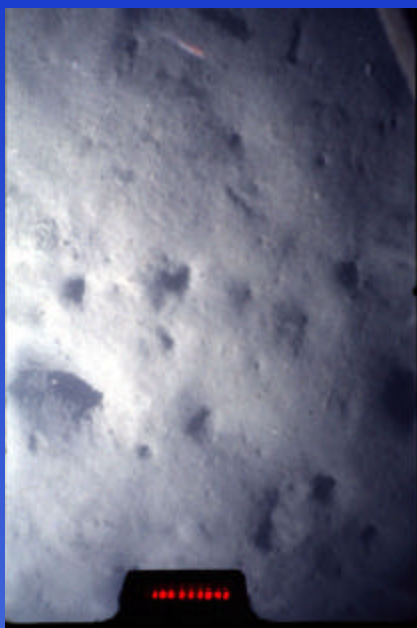
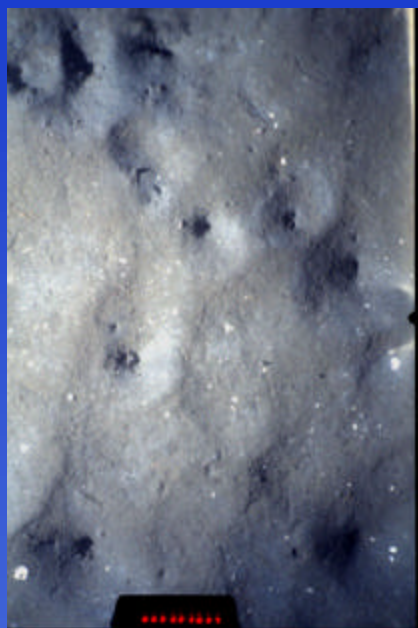
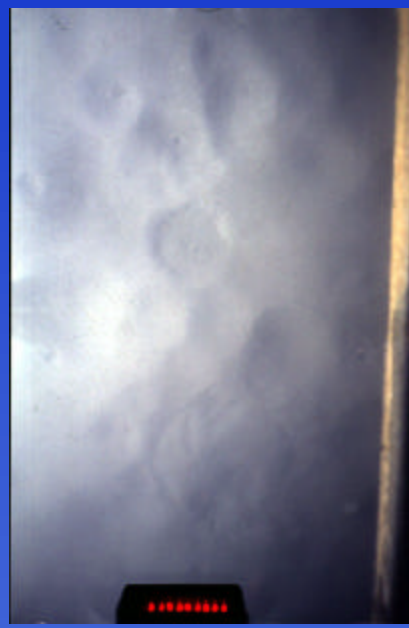
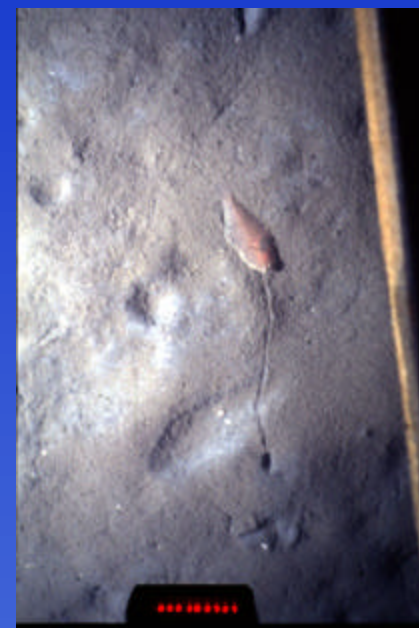
Cell LU - Station 14

Conventional Placement

Baseline

After initial dump

After 25 dumps

After 45 dumps

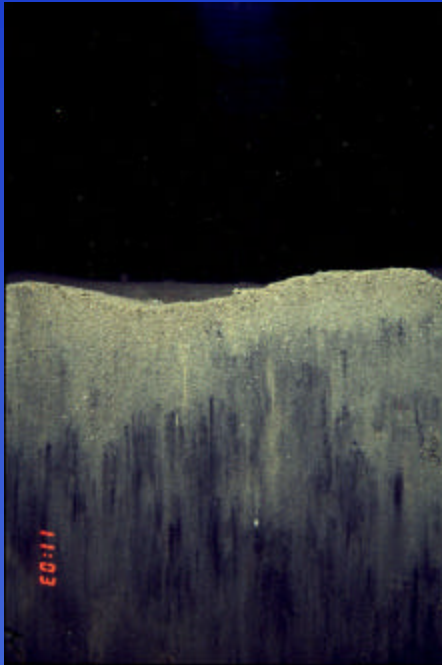
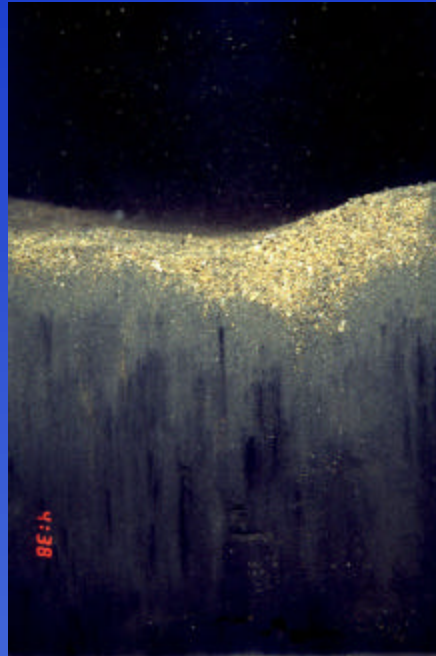
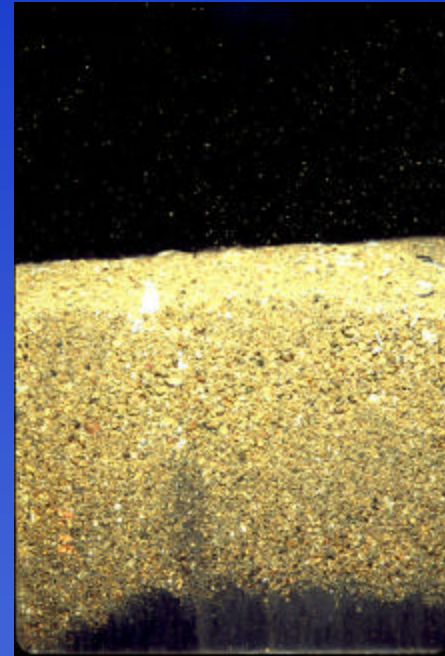
Cell LD - Station 9

Spreading Placement

Baseline

After 1 load

Cap = 2 cm

After 9 loads

Cap = 6+ cm

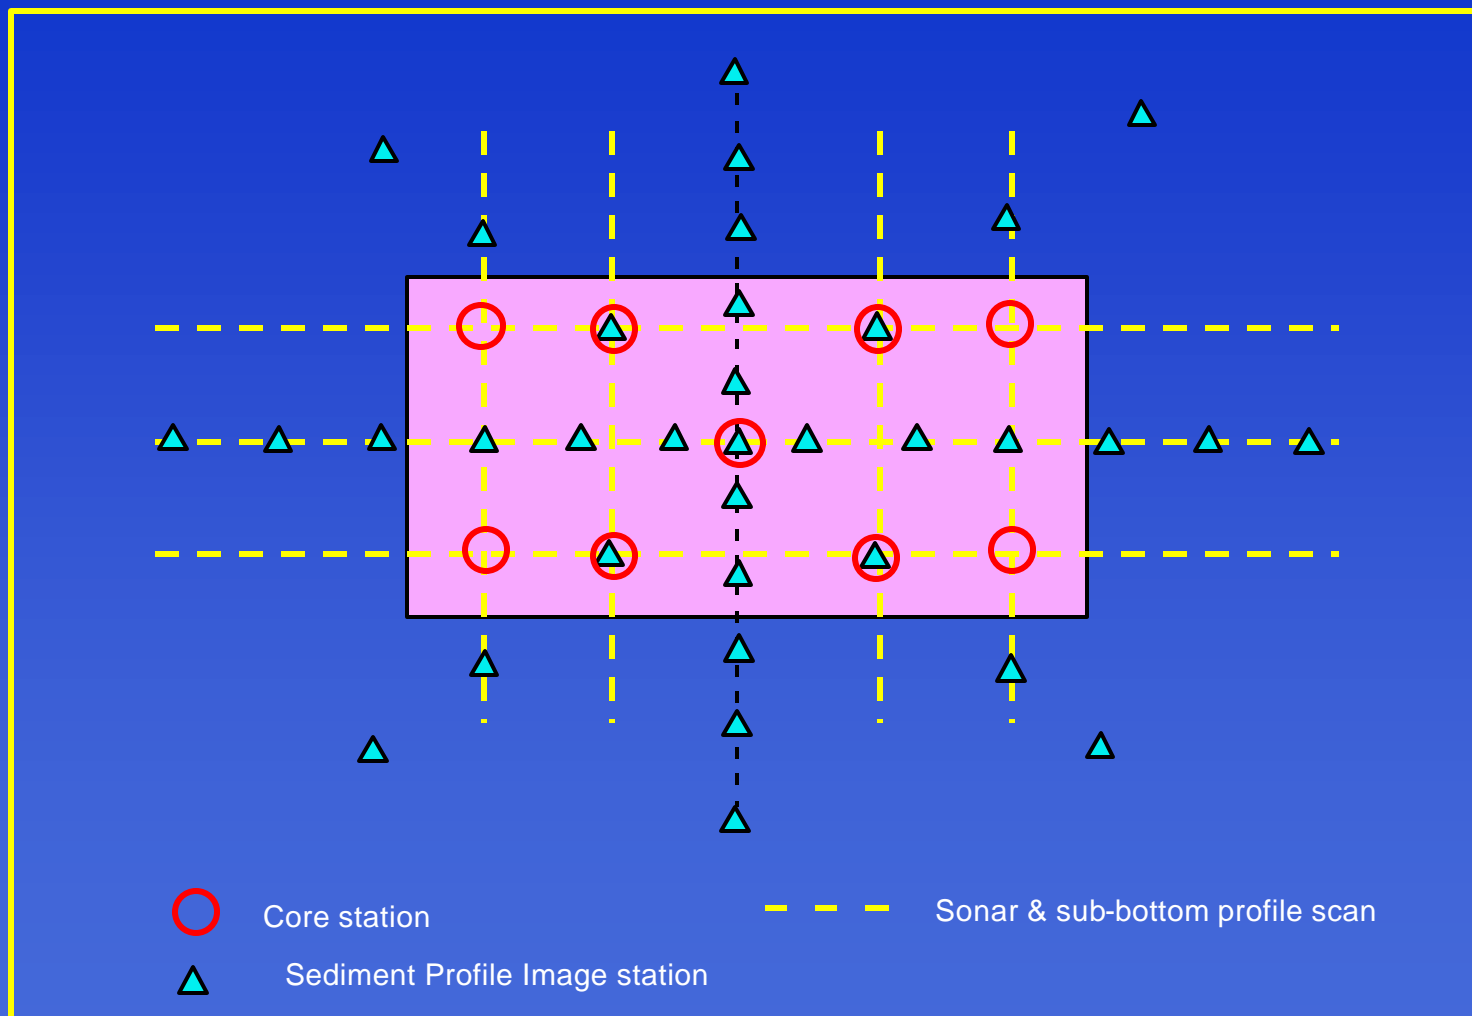
- Sediment Cores
- Sediment Profile & Plan View Photos
- Water Samples
- Side-scan Sonar
- Current meters
- ADISS system on dredge
- Underwater video
- Acoustic sub-bottom profiling

Typical Monitoring Grid
